Eco Home Solutions for Your Yard

Exterior Conditions Requiring Repair

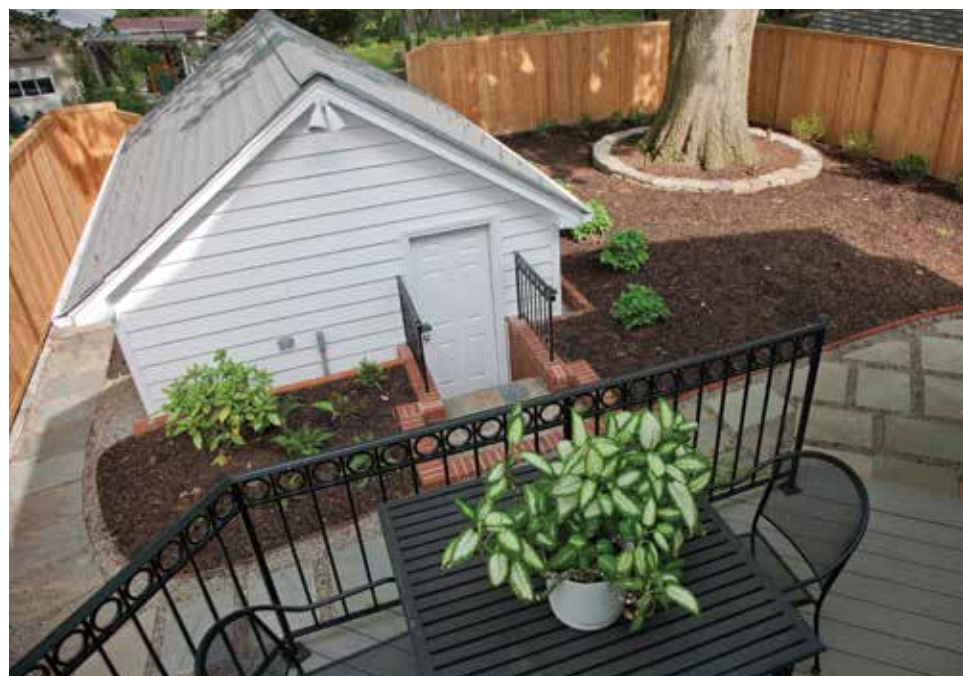
The catch basin drain is under large stones, which protects it from being blocked by yard debris. The new drain was tested during the heavy rains of spring 2014 and performed as designed. The French drain utilizes solid 4" PVC pipes with perforations on half of the circumference. It is embedded in gravel and wrapped in filter fabric to prevent clogging. It is sloped to drain. Corrugated black PVC drainpipe is not recommended for this purpose.

My firm completed a rear addition on the home this past winter and it is our standard practice to ensure that the grading is performed properly and that all affected components, such as walkways and pavement, are repaired or replaced as needed. We had observed the this yard's poor drainage during the construction process and recommended new side and rear yard walkways be installed with a French drain system constructed underneath. The French drain allowed downspout water and excess surface water to be piped to the rear property line. A catch basin with a surface drain piped to daylight was added to collect water during torrential rains (which occur more and more frequently in this area) or if the French drain becomes clogged or overwhelmed. The drain was installed at the low point of the yard to ensure that run off onto the neighbor yard was kept to a minimum.
